VERIFICATION REQUIREMENTS FOR GAS PROTECTION SYSTEMS

Technical Guidance for
Developers,
Landowners and
Consultants

Yorkshire and Lincolnshire
Pollution Advisory Group

Version 1.1 – December 2016

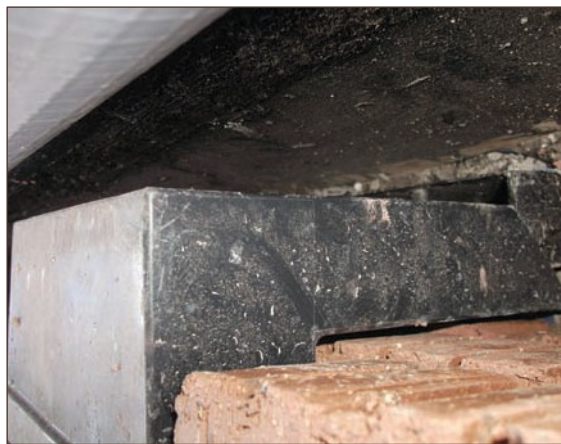
Figure A4.88 Ventilator becoming detached to fit to external block work. This is due to builders requiring increased cavity widths to achieve thermal properties expected by Building Regulations (courtesy NHBC)
