Welcome to the Planning Committee

Proposals - the aims: The applicant (SHDC) recognizes that the gates need maintenance and repair to address a number of the items raised above and to ensure their longevity. It is recognized that the gates have significant value both historically and architecturally and therefore the approach taken is to repair and conserve rather than replace. The aims are therefore as follows:

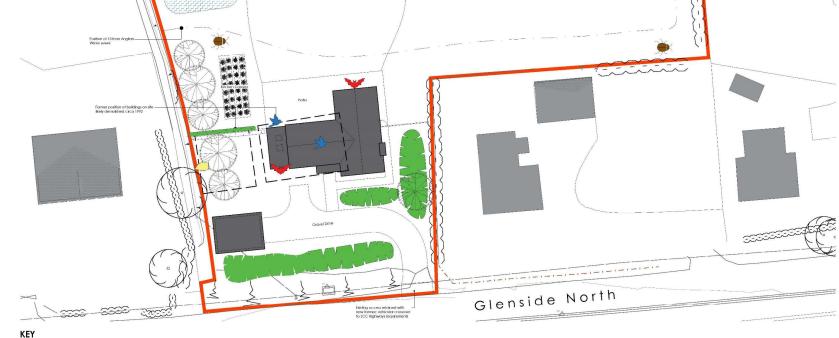
Bat Boxes

Hedgehog Houses

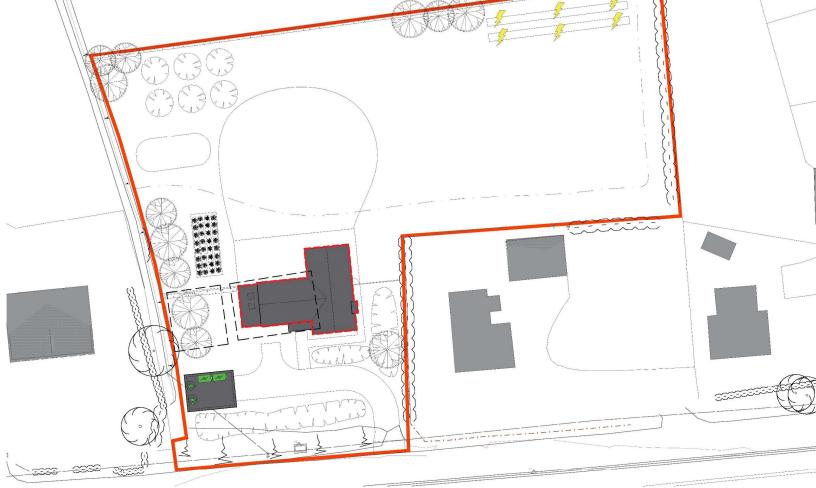
542.PD.05

Building highly insulated through the 'Fabric First' approach reducing Carbon through the life of the building
