# Welcome to the Planning Committee

Project: **Ayscoughfee Hall Museum & Gardens  
Church Gate, Spalding, PE11 2RA  
Proposed rebuild of section of collapsed  
forecourt wall.**

Drawing Title:  
**Plans, sections, elevations and photos as existing and proposed.**

200kW/800kWh  
MICRO ENERGY STORAGE PROJECT  
BATTERY BOX  
Plan Depicting Battery Layout  
**BATTERY LAYOUT PLAN**

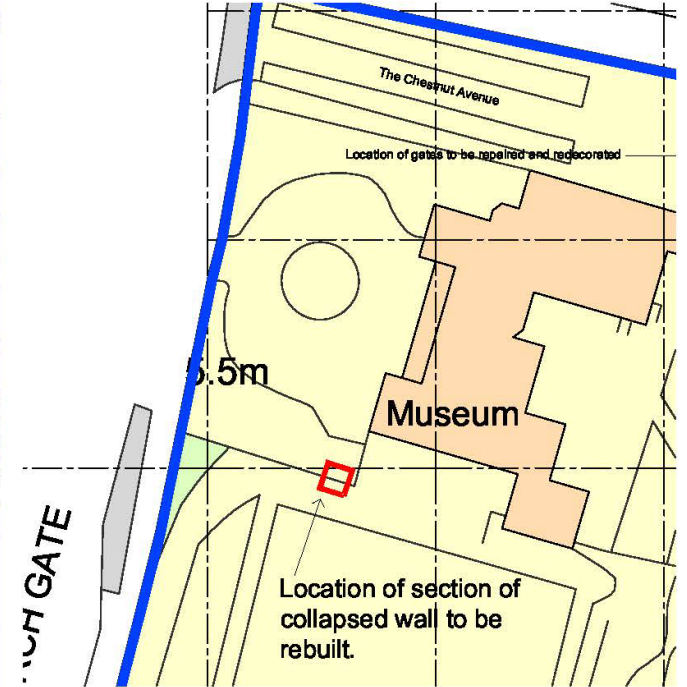
**Site Block Plan**

Scale 1:500 @ A3

Site of proposed works outlined in red

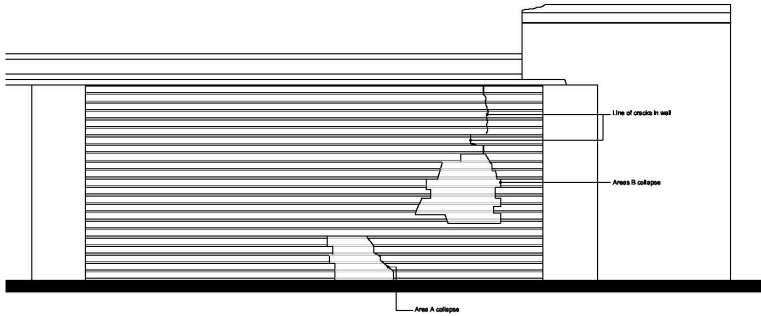
South elevation of wall as existing  
Scale 1:20

The wall is believed to have been constructed in the early 18th Century. It is of brick construction and its height varies along its full length. The height of the wall has been altered historically. Historic repairs are apparent in various locations along its length. There are large areas where the wall appears to have been repaired using a cement mortar and consequently there is damage and erosion to the brickwork throughout. There are two areas where the face of the wall on the south side has collapsed, identified as areas A and B on this drawing. In summary, the main elements of deterioration to be addressed are as follows:

The walling is constructed of a traditional red brick, with lime mortar (though much C20 cement based repointing has occurred). The coping to the wall is documented as being Grit Stone and this sits asymmetrically on top of the wall. The wall height varies, but at the point of interest is approximately 1700mm from GL, to underside of coping in the south side.

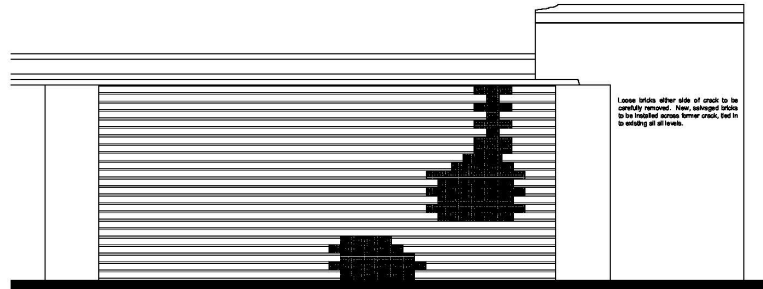
South elevation of wall as proposed  
Scale 1:20

Areas A and B to be infilled using salvaged bricks and matching surround work. In-fill to match existing in all respects. Mortar to be traditional lime mix. Cement to be used. Exact extent of in-fill to be determined on site following removal of remaining residual areas. In-fill brickwork to be in-situ using using full bricks wherever possible.

Note that in all cases the outline of the in-fill works to shown indicates only and will be determined following the removal of residual loose brickwork. In any event, in-fill should not be more extensive than that which is required to ensure sound construction. In all cases, new brickwork should be laid in straight joints turning through existing courses are to be avoided. In-fill should be to full depth of the area of collapse.

1. Careful removal of residual loose bricks to areas A, B and crack.
2. Tooling out of edges of fill area and preparation for new in-fill brickwork.
3. Clearing and preparation of existing salvaged bricks for reuse.
4. Construction of in-fill brickwork using salvaged bricks, set in traditional lime mortar. In-fill work to match existing surround work in all respects and to completely fill cavities. All new brickwork to be securely tied to existing.
5. Brush down of full wall surface to leave wall clean, in-fill to be as inconspicuous as possible.

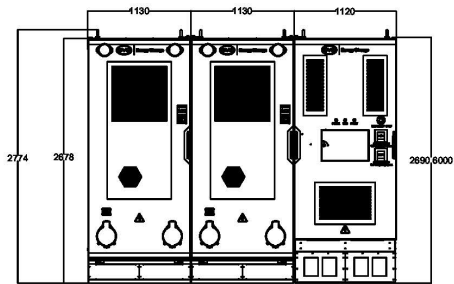
front view

200kW / 800kWh  
MICRO ENERGY STORAGE UNIT  
BATTERY BOX  
BATTERY EQUIPMENT  
SMART STRING ESS  
PLAN AND ELEVATIONS

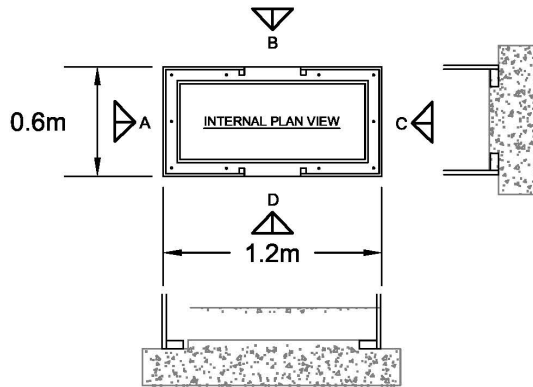
**PLAN**

<b>BATTERY BOX</b>	
	AMP CLEAN ENERGY 1 DOVER STREET LONDON W1S 4LD
200kW / 800kWh MICRO ENERGY STORAGE UNIT	
Battery Box Plan depicting Electrical Cabinet	
<b>ELECTRICAL CABINET PLAN AND ELEVATIONS</b>	
<b>PLAN 5</b>	
Scale	1:25 @ A3

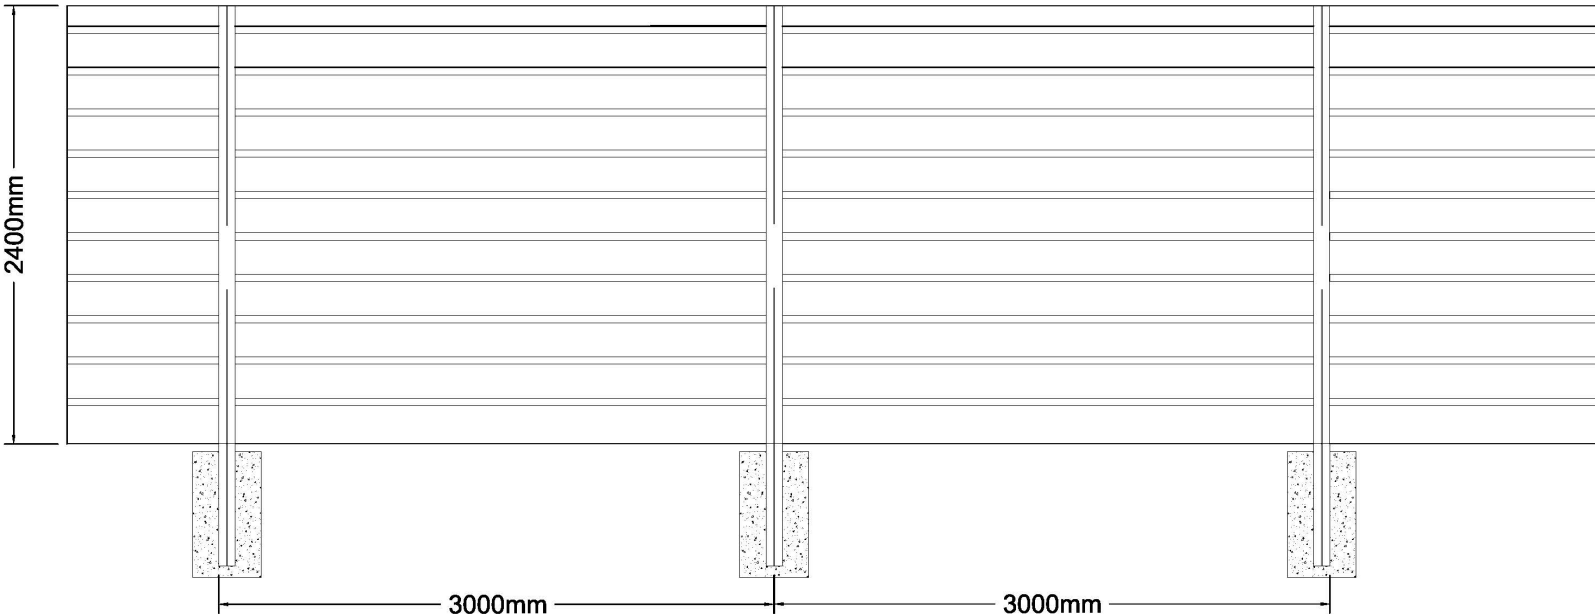
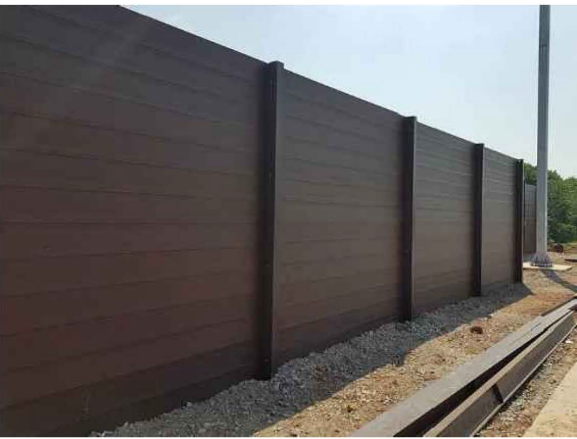
# FENCE ELEVATION

Solid acoustic fence is supplied by Tilon CG Ltd  
 Reflective B3 rating, Absorptive A3/B3 rating  
<https://tiloncg.com/noise-barriers/>

AMP Clean Energy 1 Dover Street London W1S 4LD
200kW / 800kWh MICRO ENERGY STORAGE UNIT BATTERY BOX 2.4m HIGH SOLID ACOUSTIC FENCE ACOUSTIC FENCE ELEVATIONS	
<b>PLAN 6</b>	
Scale AS SHOWN
