VERIFICATION REQUIREMENTS FOR COVER SYSTEMS

Technical Guidance for
Developers,
Landowners and
Consultants

**Yorkshire and Lincolnshire
Pollution Advisory Group**

Version 4.1 – June 2021

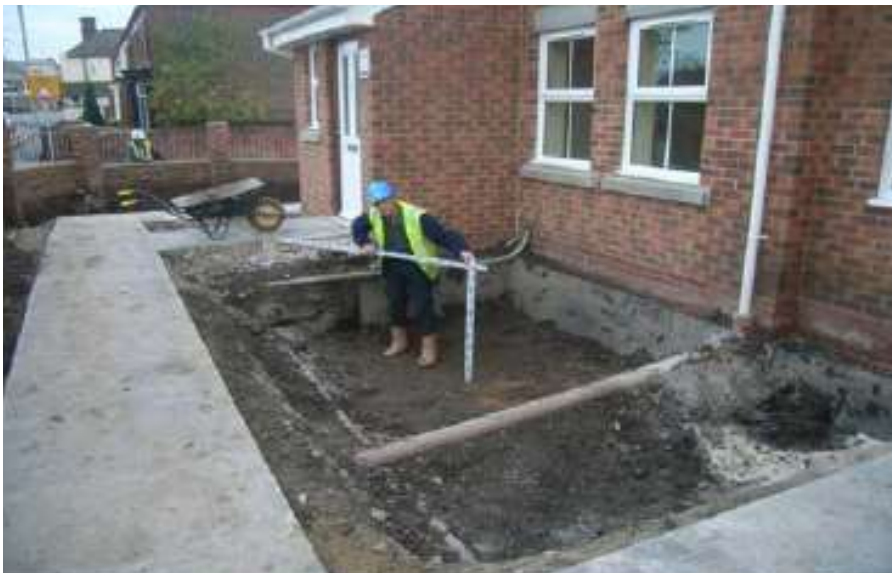
Photograph 4:
Depth check of inert cover within areas of front gardens.

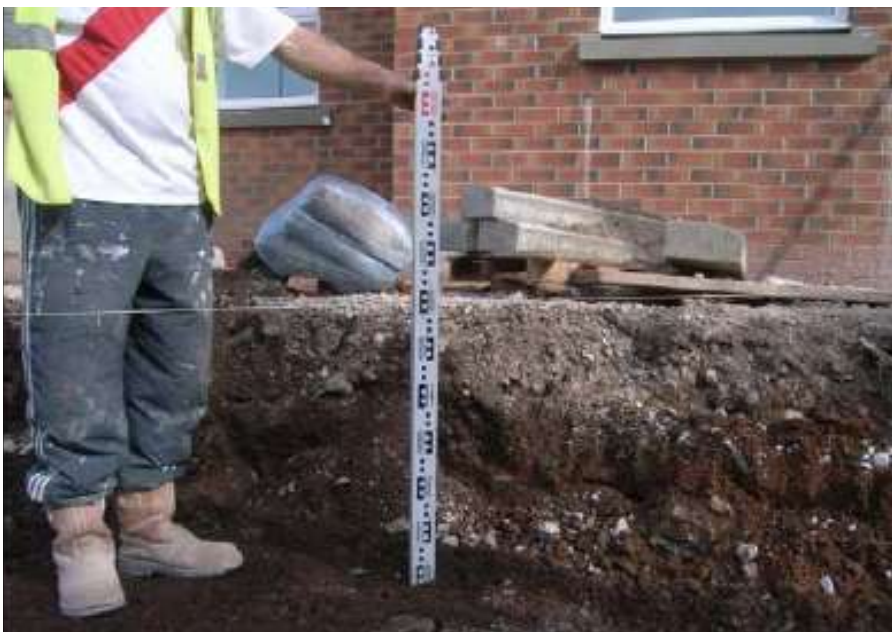
Photograph 5:
Depth check of inert cover within rear gardens. Taut string line spans across excavation.
